**SAN FRANCISCO BAY CREOSOTE PILING REMOVAL
AND PACIFIC HERRING HABITAT RESTORATION PROJECT**

TECHNICAL MEMORANDUM 3:

HABITAT RESTORATION SUITABILITY AND PILING REMOVAL:
TIER III FIELD INVESTIGATIONS AND SITE SELECTION RECOMMENDATIONS

January 21, 2015

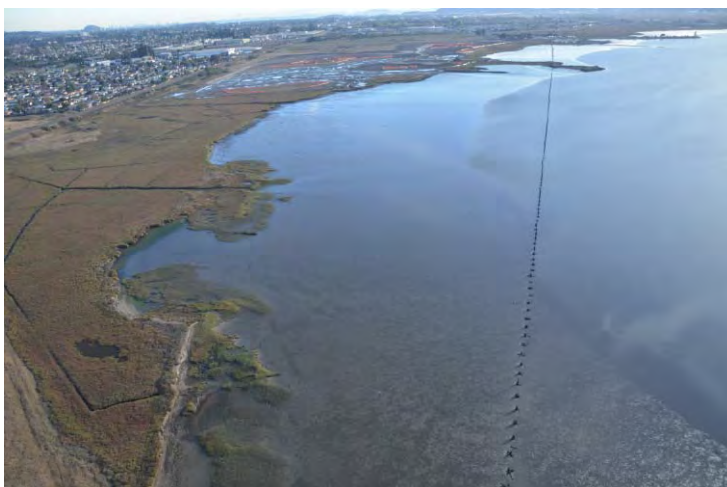
Low tide view of the pipeline trestle crossing intertidal mudflats

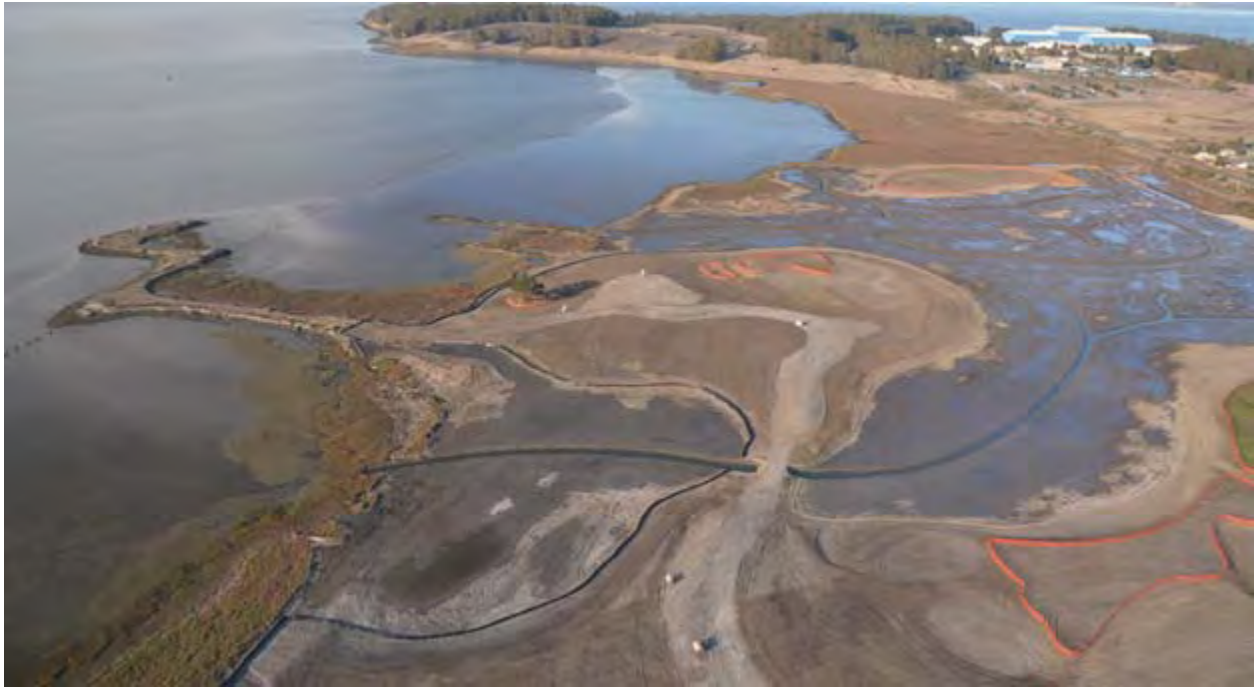
Upland access conditions to the pipeline trestle are not suitable through the Breuner Marsh (foreground) or Point Pinole Regional Shoreline (background).

In addition to the lack of merit for piling removal, the site poses significant logistical challenges due to its shallow nature and great distance from deep water. In full consideration of the site conditions, the pipeline trestle may serve better to assist in developing a support for a “living shoreline” reef structure to assist in protecting the marsh frontage at Breuner Marsh and Giant Marsh from the continuing and exacerbated erosion presently occurring and anticipated with sea level rise. While sediment probing was not attempted directly adjacent to the piles due to concern about vessel impact on undetected submerged piles, it is highly likely that the remnants of the prior pipeline remain buried at a shallow depth along this alignment and would further provide support for reef structures placed on this axis.

This site is recommended for dismissal as a candidate site for a creosote pile and herring habitat restoration project.

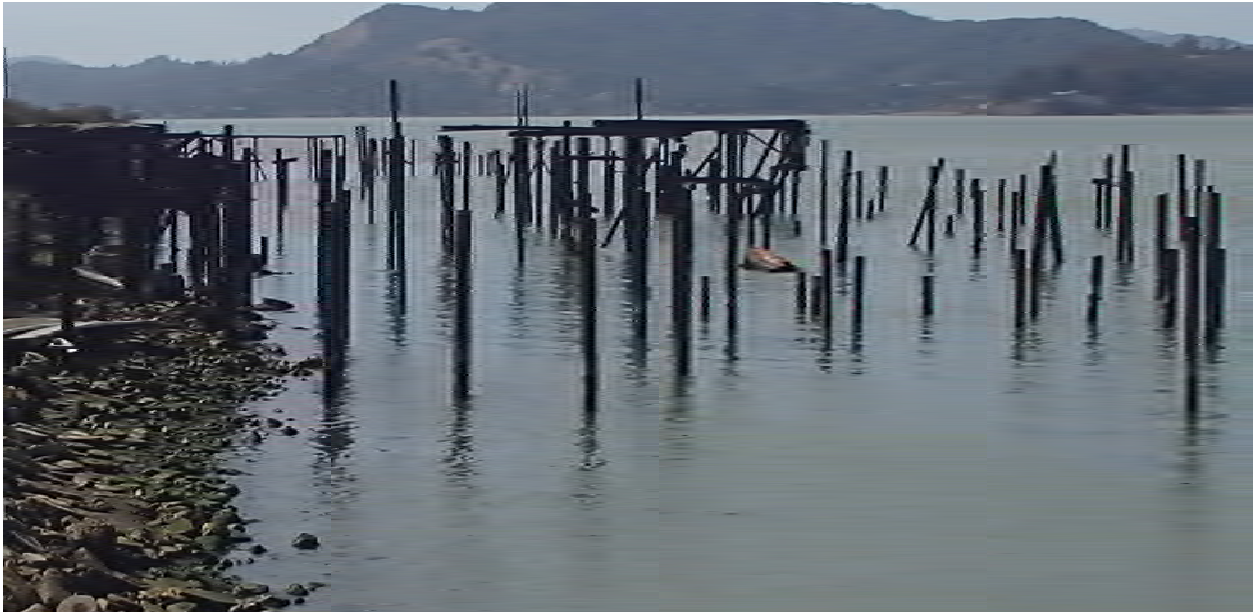
In addition to the horizontal substrate, the site has extensive vertical pile surface. These piles have considerable exposed surface creosote in areas above the mean high tide line and less obvious surface creosote below the mean high tide line. The piles support a good coverage of ephemeral algae, but very little in the way of encrusting invertebrates. None of the piles at this site are wrapped and given the anticipated age, condition of piles, and lack of marine fouling community development, it is believed that these piles likely are leaching creosote derivatives at a moderately toxic level and the piles pose a moderate risk to herring spawning.

Pile field at Richmond Red Rock Warehouse. The rubble shoreline and submerged debris that provide potential preferred spawning substrate over vertical piles can be seen in this low tide photograph.

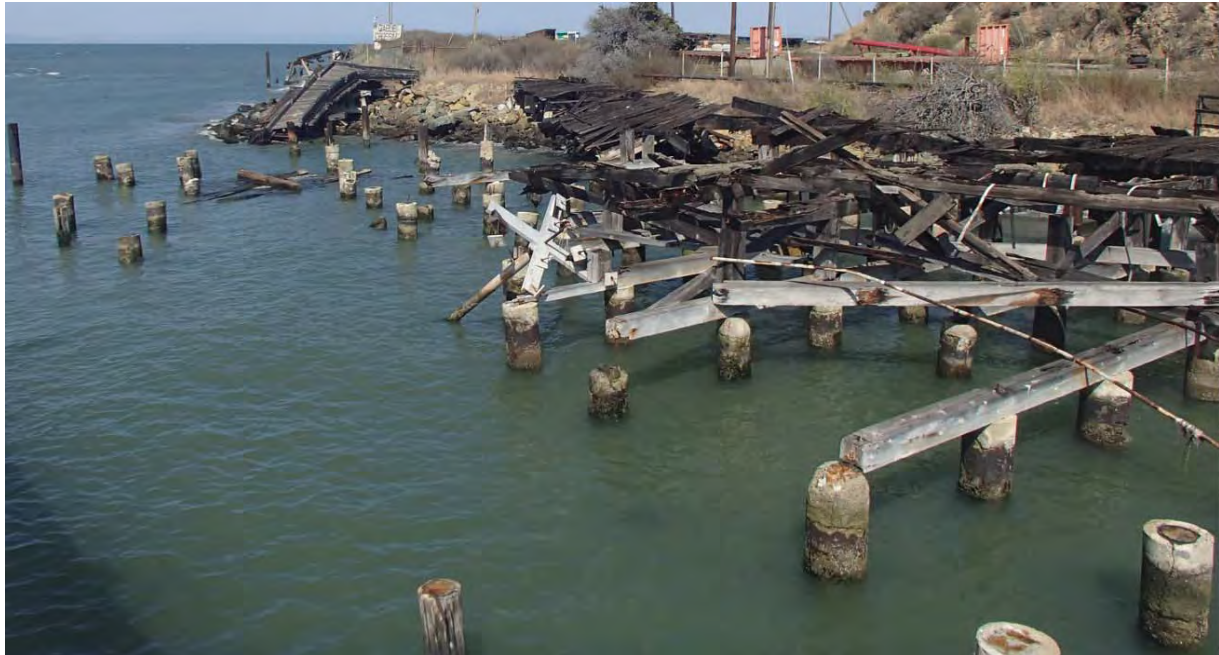
Failed northern section of the Richmond Terminal 4 pier revealing the principal construction of the pier to be short concrete wrapped wood piles supporting a lattice work of beams and cross members that held the pier deck. Deck support beams and encased piles both show evidence of creosote treatment.

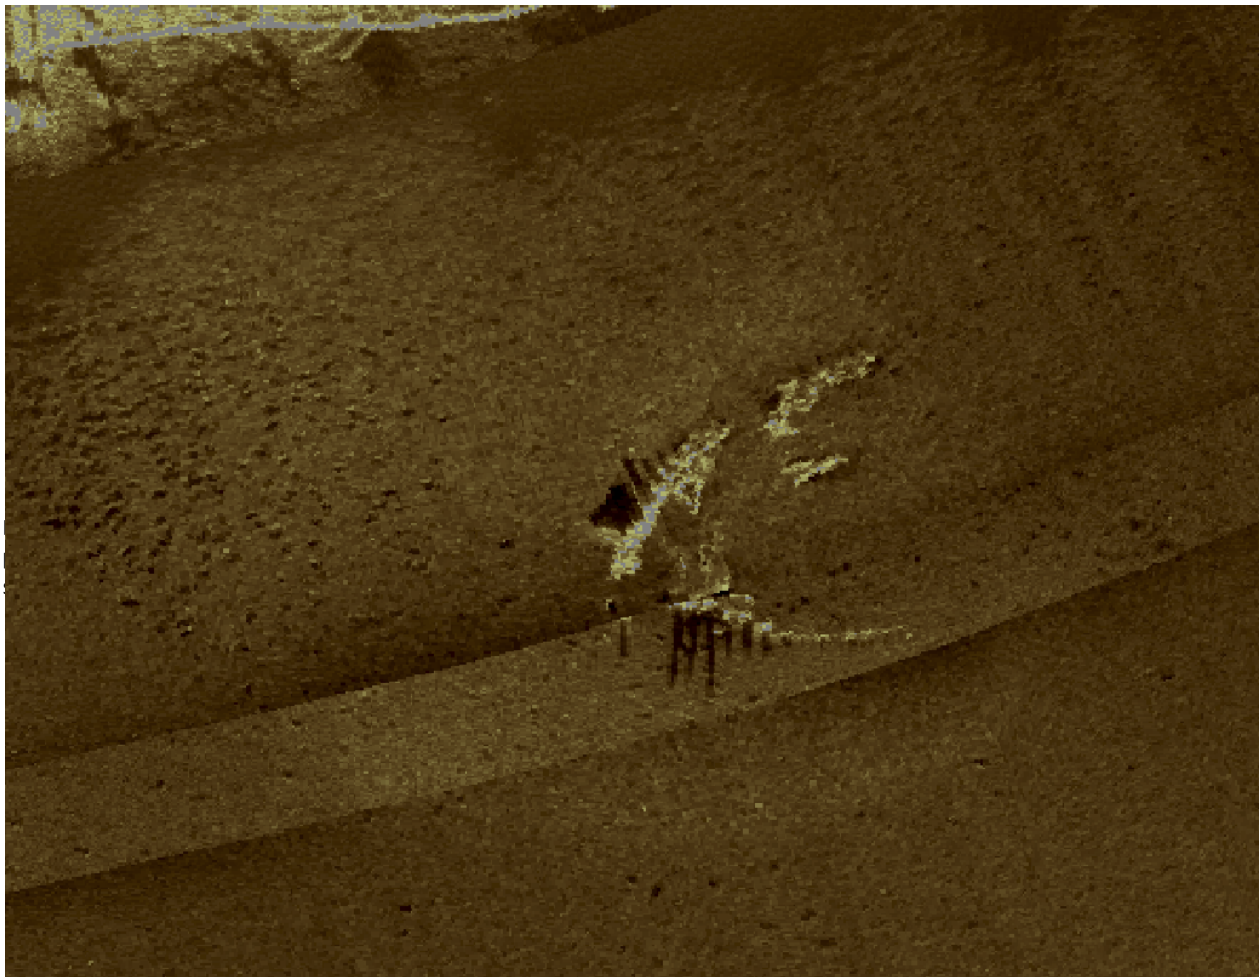
There is one sunken vessel feature of potential historic interest on the site, both because of its apparent construction and its location within the sediment strata. Immediately south of the ferry pier, the scour hole that formed where flows breached the pier wall, has excavated sediment to a depth of -20 feet MLLW from a starting depth of approximately -8 feet MLLW. This scouring has exposed the bow of what appears to be a wooden vessel that was buried at least 1.2 meters (4 feet) below the bay mud prior to the scouring. This vessel is not of the construction, nor placement age of the other derelict vessels on the site. Work to remove the pier could be accomplished in a manner that completely avoids this vessel and the scour pit would likely reaccrete sediment over some or all of the vessel. In the event this site were to advance to design and planning, an evaluation of the potential historic resource importance of this vessel ship should be made and, if required, measures taken to protect the vessel from damage undertaken.

Interferometric sidescan sonar image of ship ribs at bow emerging from the bottom within a scour hole generated where the piling wall of the ferry pier has been breached. The vessel is a minimum of 4 feet below the sediment surface and may have been buried in the sediment prior to pier construction.

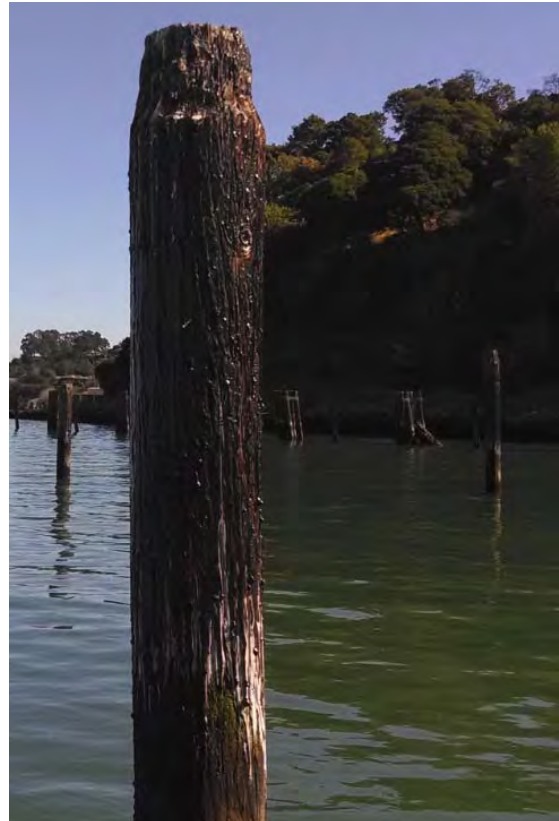
Given the high frequency of herring spawning in this area, combined with the abundance and condition of creosote piles at this site, it is anticipated that creosote pile toxicity poses a high threat to spawning herring at the El Campo Site Marina.

Creosote condition on marina piles. Shoreline pile dolphins in the background support horizontal submerged pilings as well.

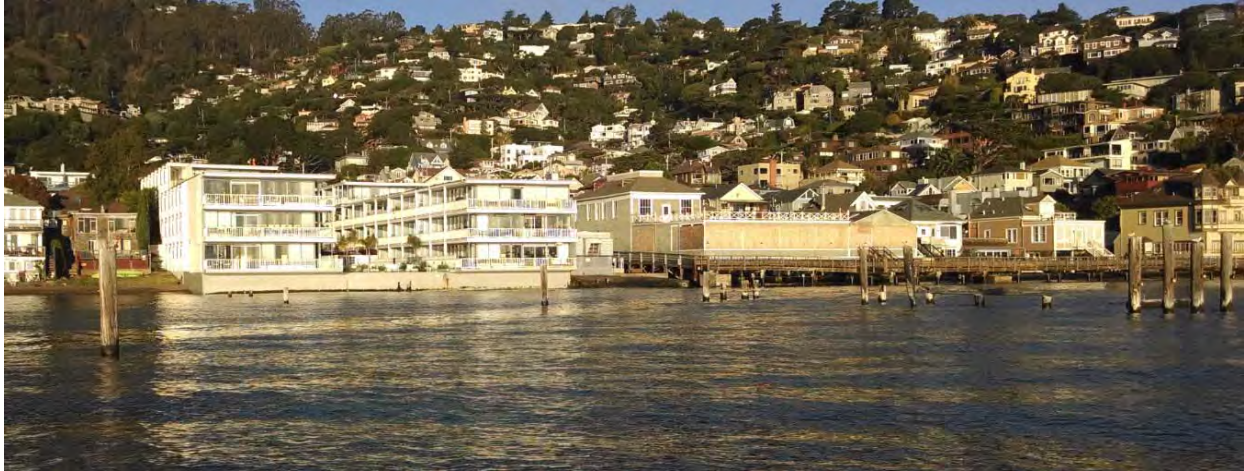
Current condition of the pile field at Sausalito 3 (Nunes Brothers Boat & Ways Company piers).
