# CALIFORNIA STATE COASTAL CONSERVANCY

SAN FRANCISCO BAY CREOSOTE REMOVAL AND HERRING HABITAT RESTORATION PROJECT

ATTACHMENT A – PROJECT DESCRIPTION

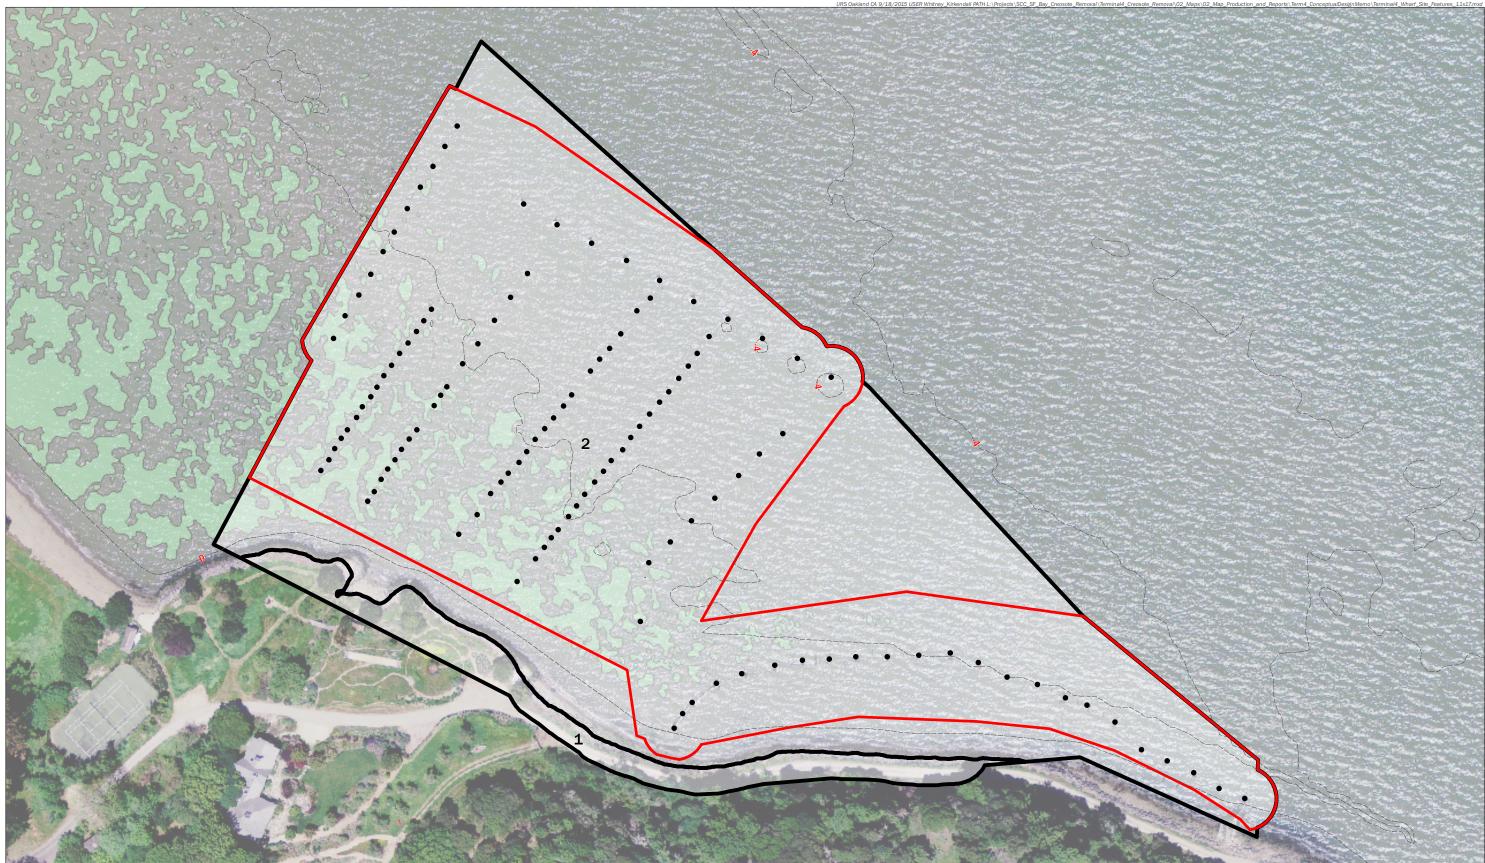
FIGURE 12 Red Rock Warehouse Site Pile Removal Approach

**Figure 12** shows areas where pile removal would be performed. The concrete foundation is on the shore and is assumed to remain in place. A BCDC permit application for the piling removal dated 1999 from the City of Richmond shows more decking than is currently visible. Parts of the missing decking have sunk in place, while other portions may have floated away. A large rubble field – approximately 10,360 square feet – containing both timbers and concrete flooring material occurs within the core of the old warehouse footprint. As noted earlier, up to three dozen pile butts extend above the seafloor but below the lowest low tide, and there are some large metal debris items that pose significant navigation hazards if the piles are removed and other debris are left.

- Removal of decking above the water
- Removal and disposal of approximately 350 wooden pilings on the beach and in the water.
- Re-grading and stabilization of unstable embankment above the beach where needed
- Selective removal and disposal of wooden and concrete decking and other debris from below the water.
- Trimming and debris removal of piles that have broken or break above the sea floor.
