Department of Fish and Wildlife

Subject: Progress on Isthmus slough bridge native oyster restoration effort

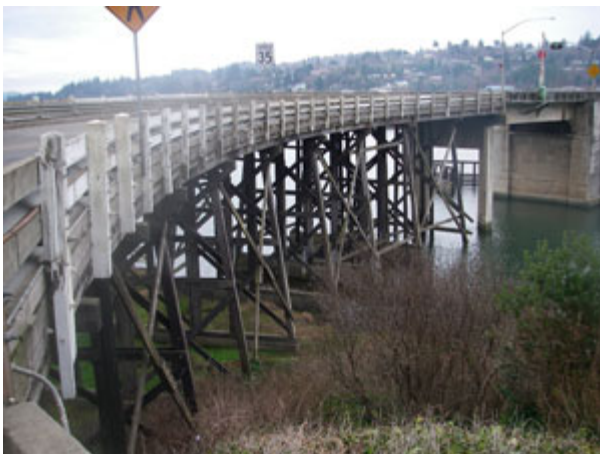
Figure 1: Isthmus slough bridge 2010

In cooperation with Oregon Department of Transportation (ODOT), ODFW worked to help mitigate for work performed on the Isthmus slough bridge. The bridge, built in the early 1900's, still had wood supports which were replaced with steel.

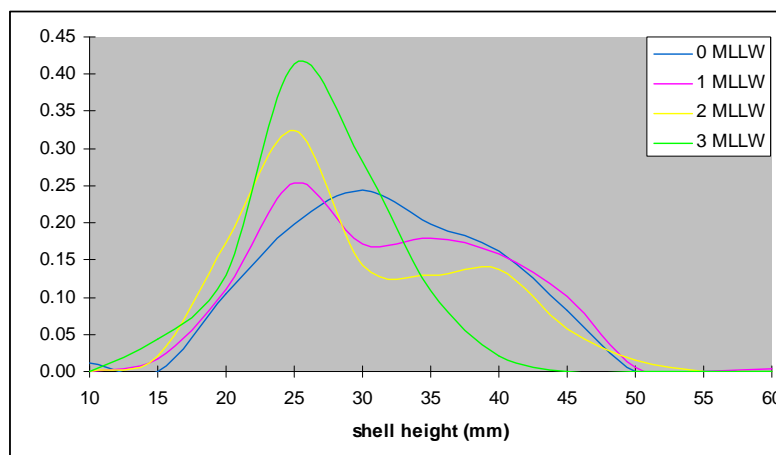
Length frequencies trended to smaller oysters in the higher strata, as is casually observed throughout their range. L/F distribution was found to be very significantly lower ($P = <0.001$) at 0 and +1 MLLW elevations when compared to +3 MLLW elevation using a Mann-Whitney rank sum test. Using the same test, significant differences were detected between l/f data from 0 and +1 MLLW when compared to +2 MLLW ($p=0.014$, $p=0.004$).

Figure 2: histogram of size frequency bins at tidal strata

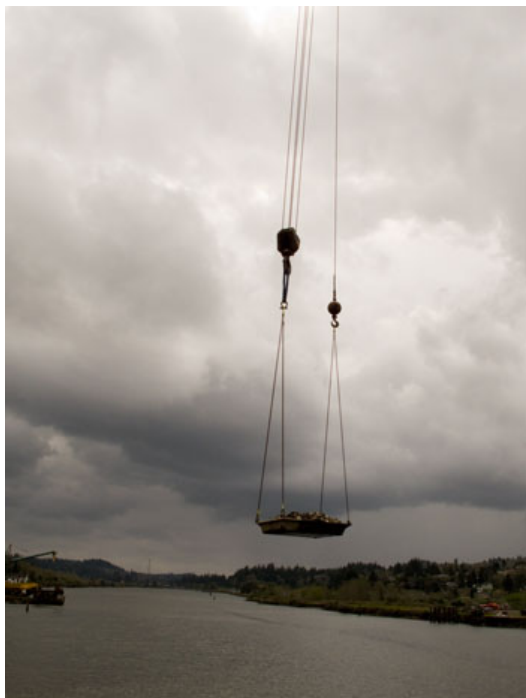
Figure 5: Crane moving shell material

After the work was complete, ten cubic yards of whole Pacific oyster shell was placed at the tidal flat areas roughly between -1 and +2 MLLW. Crafty constructions crews, more familiar with a crane than a boat, made an interesting way of placing the material.

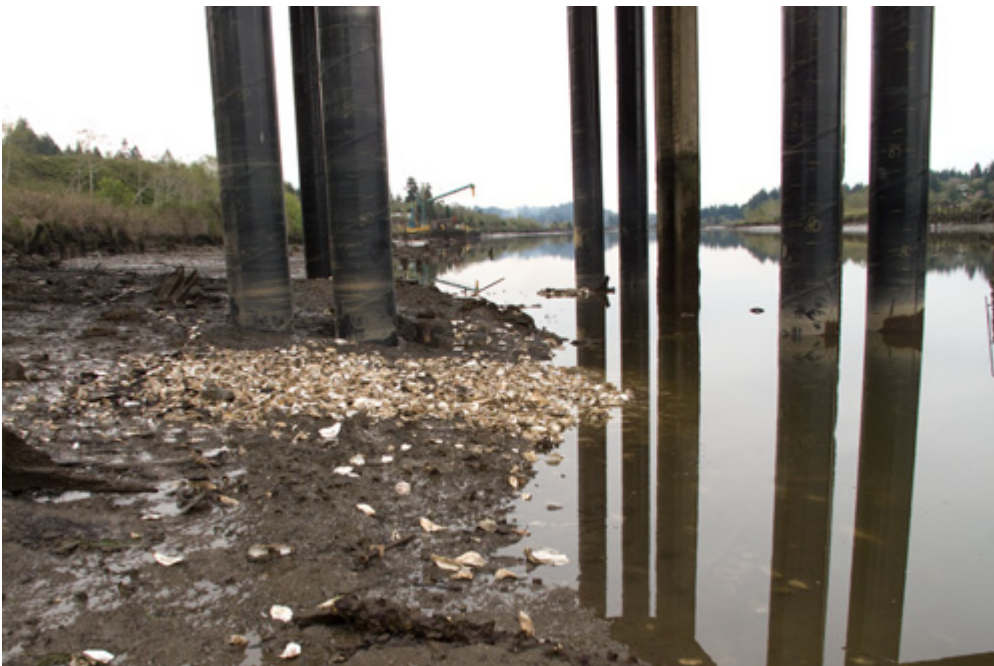
Figure 6: Post work view, most new shell below pictured tidal level
