**SAN FRANCISCO BAY CREOSOTE PILING REMOVAL
AND PACIFIC HERRING HABITAT RESTORATION PROJECT**

TECHNICAL MEMORANDUM 3:

HABITAT RESTORATION SUITABILITY AND PILING REMOVAL:
TIER III FIELD INVESTIGATIONS AND SITE SELECTION RECOMMENDATIONS

January 21, 2015

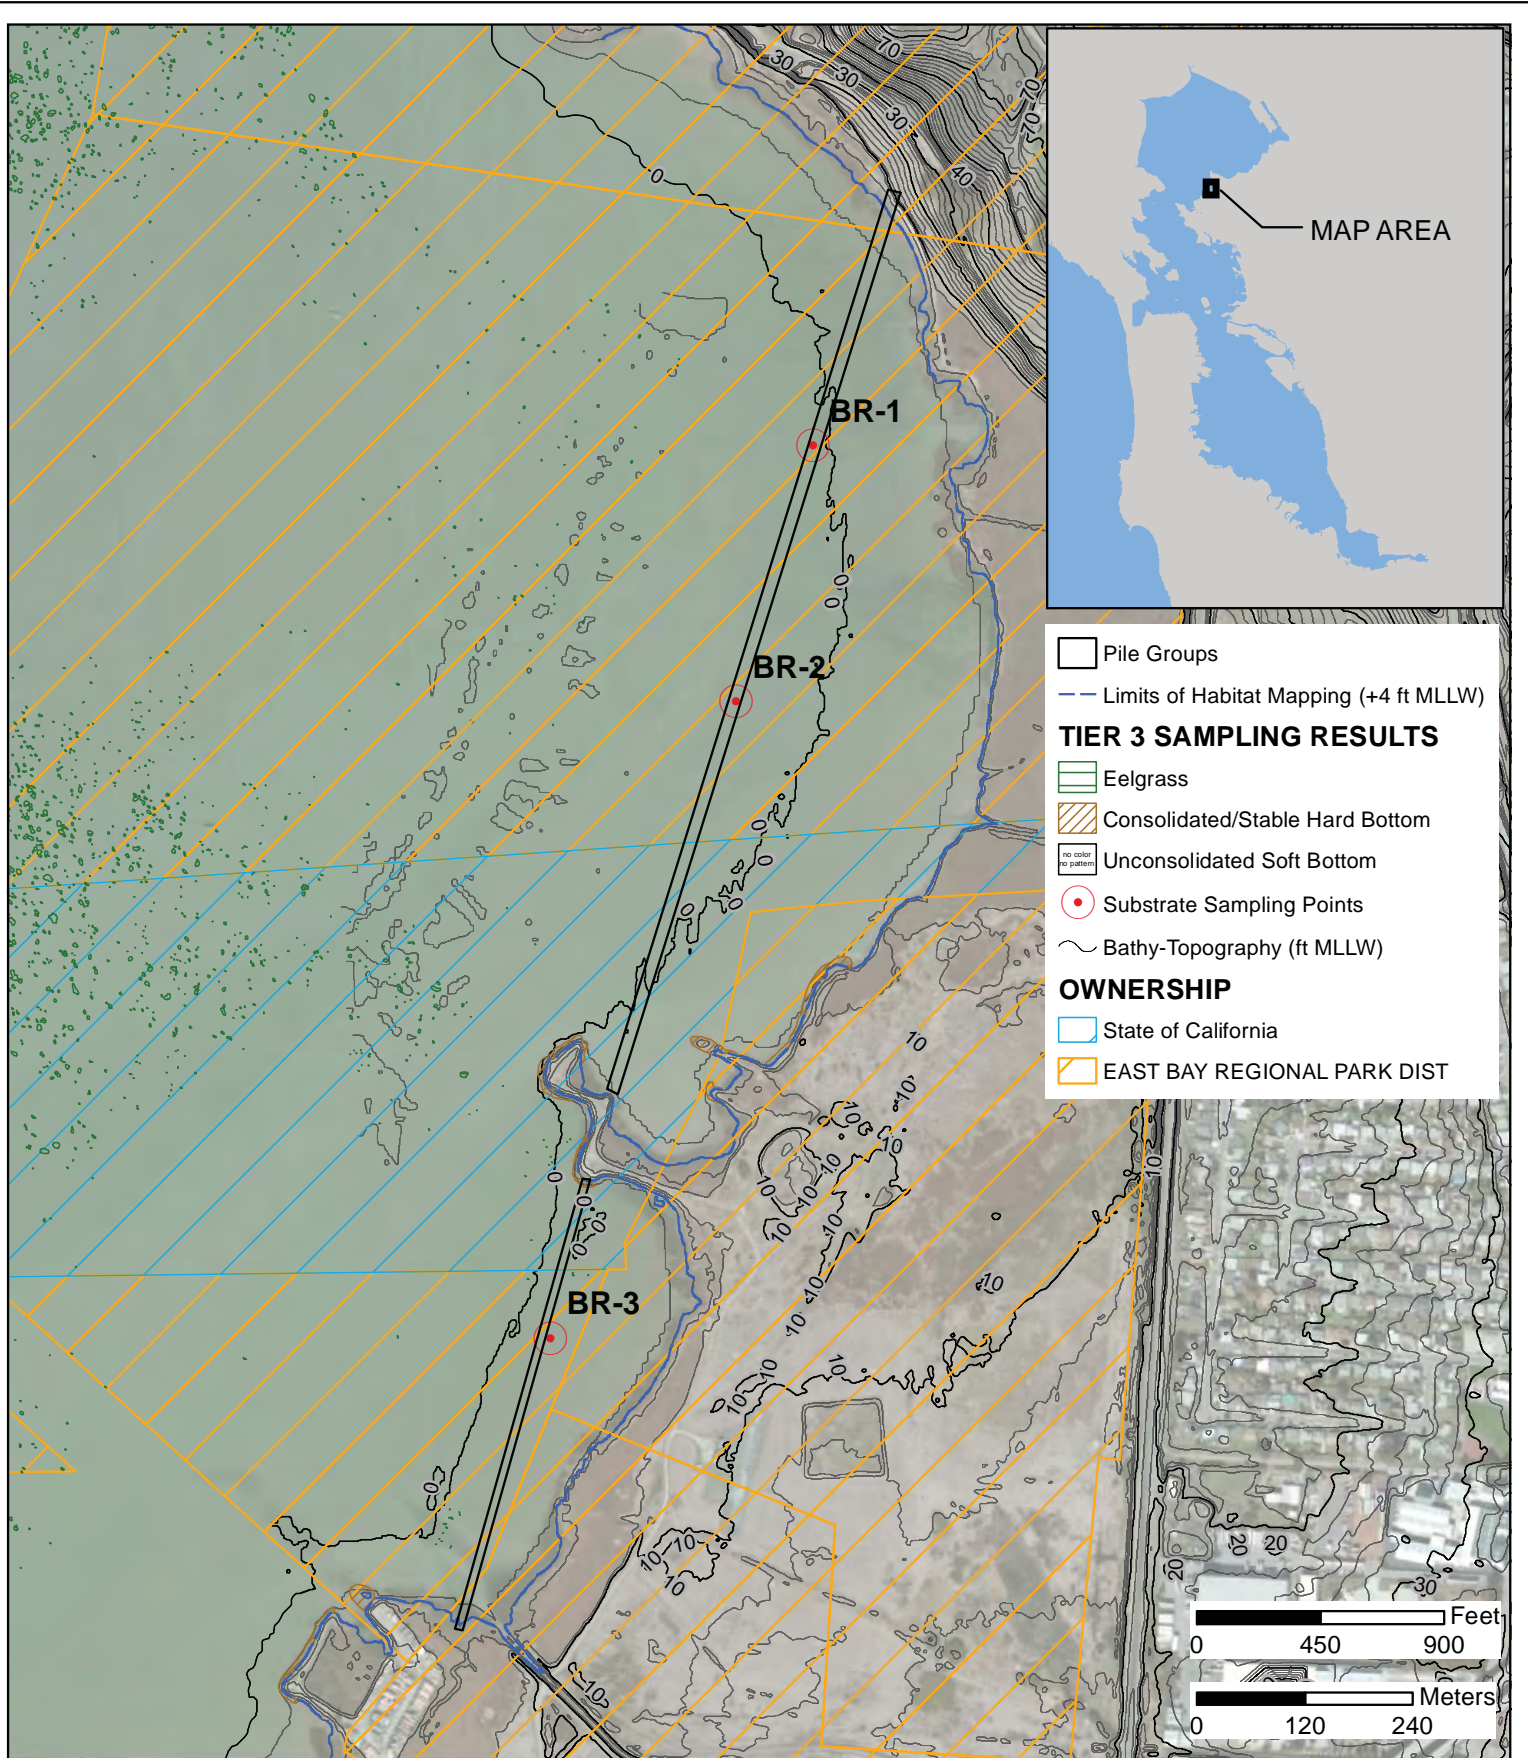
Figure 2

Pipeline Trestle - Breuner Marsh
 SAN FRANCISCO BAY CREOSOTE PILING REMOVAL
 AND PACIFIC HERRING HABITAT RESTORATION PROJECT

The site sediment characteristics were investigated at three locations, identified as BR-1 to BR-3 located along the trestle alignment (Figure 2). Additional sediment probing was performed bayward of the trestle as water was too shallow during the low tide to hazard a passage through the trestle piles, which were nearly fully submerged at the time of sampling.

Throughout the wide-ranging subsurface probing, no stiff strata were located that would support extensive surface loading, and no probe refusal was noted to sediment depths exceeding 150 cm (59 inches). This suggests that if reef habitat were desired, it may be required to build up a spread footing foundation to support the reef structure. This may be accomplished by placement of interlocking gravel or shell base material prior to reefs to expand the loading of reefs.

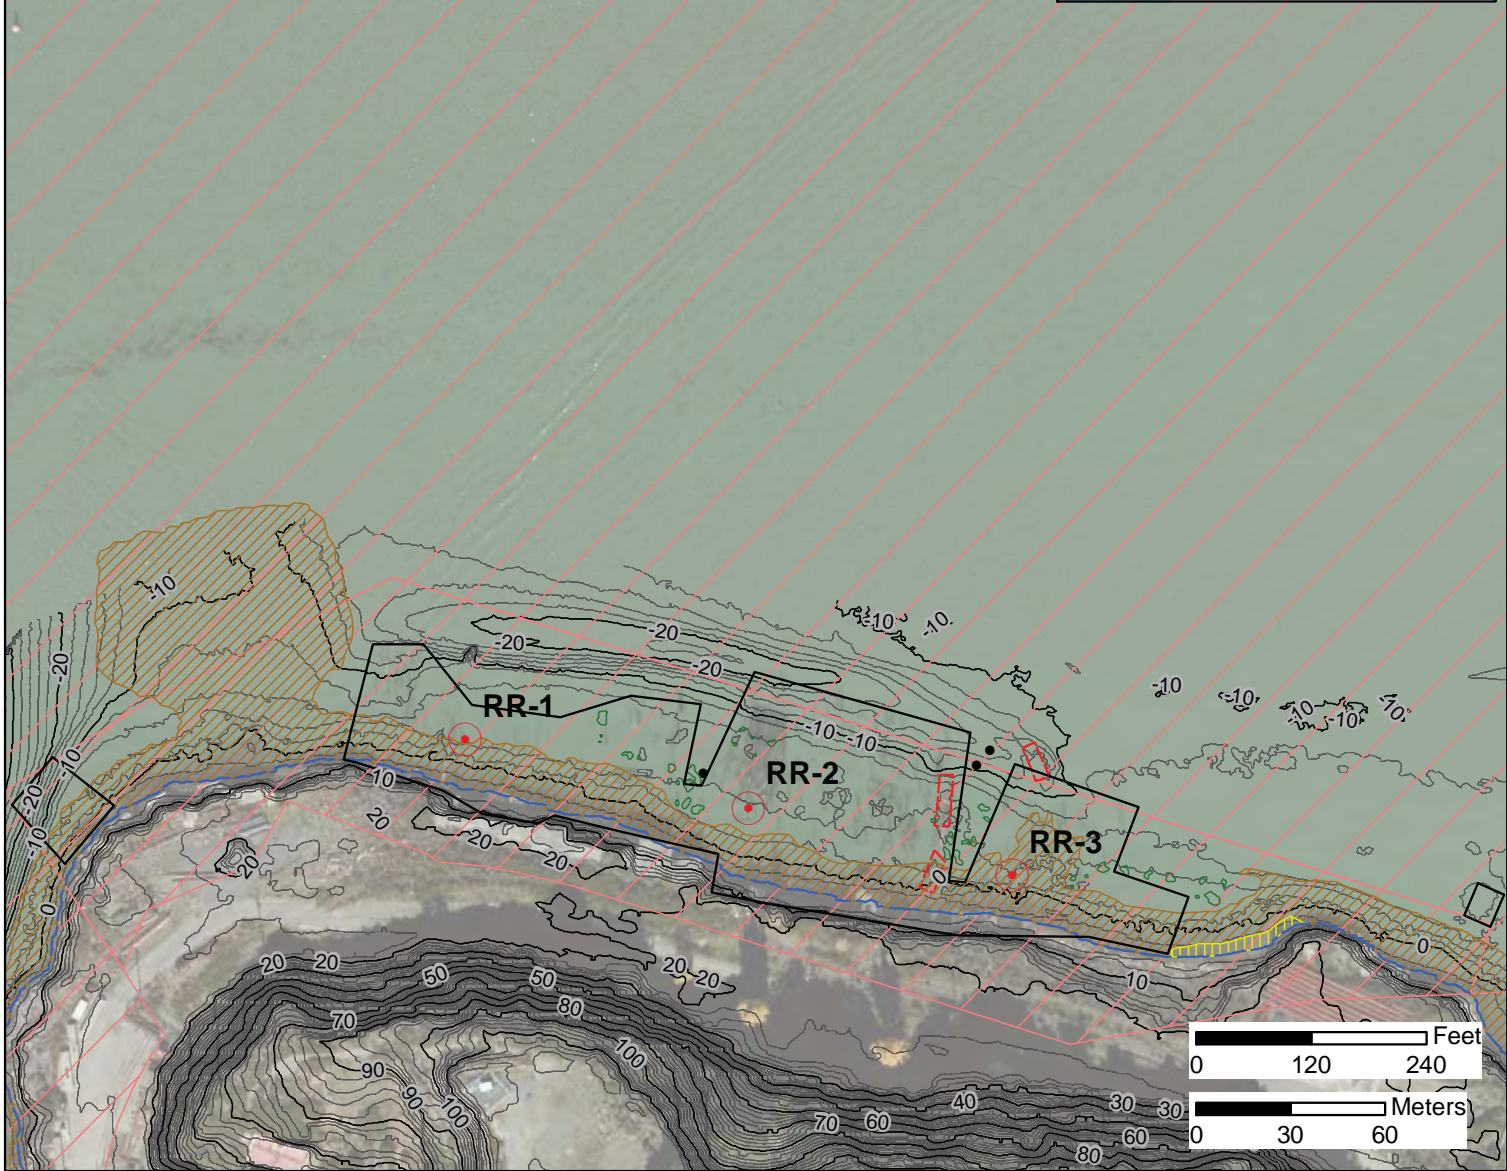
Figure 3

Richmond Red Rock Warehouse
 SAN FRANCISCO BAY CREOSOTE PILING REMOVAL
 AND PACIFIC HERRING HABITAT RESTORATION PROJECT

The site sediment characteristics were investigated at three locations identified as RR-1 to RR-3 located within the warehouse piling site (Figure 3), with additional sediment probing being performed throughout the site at areas close to the shoreline, mid-distance to the channel, and near the channel edge.

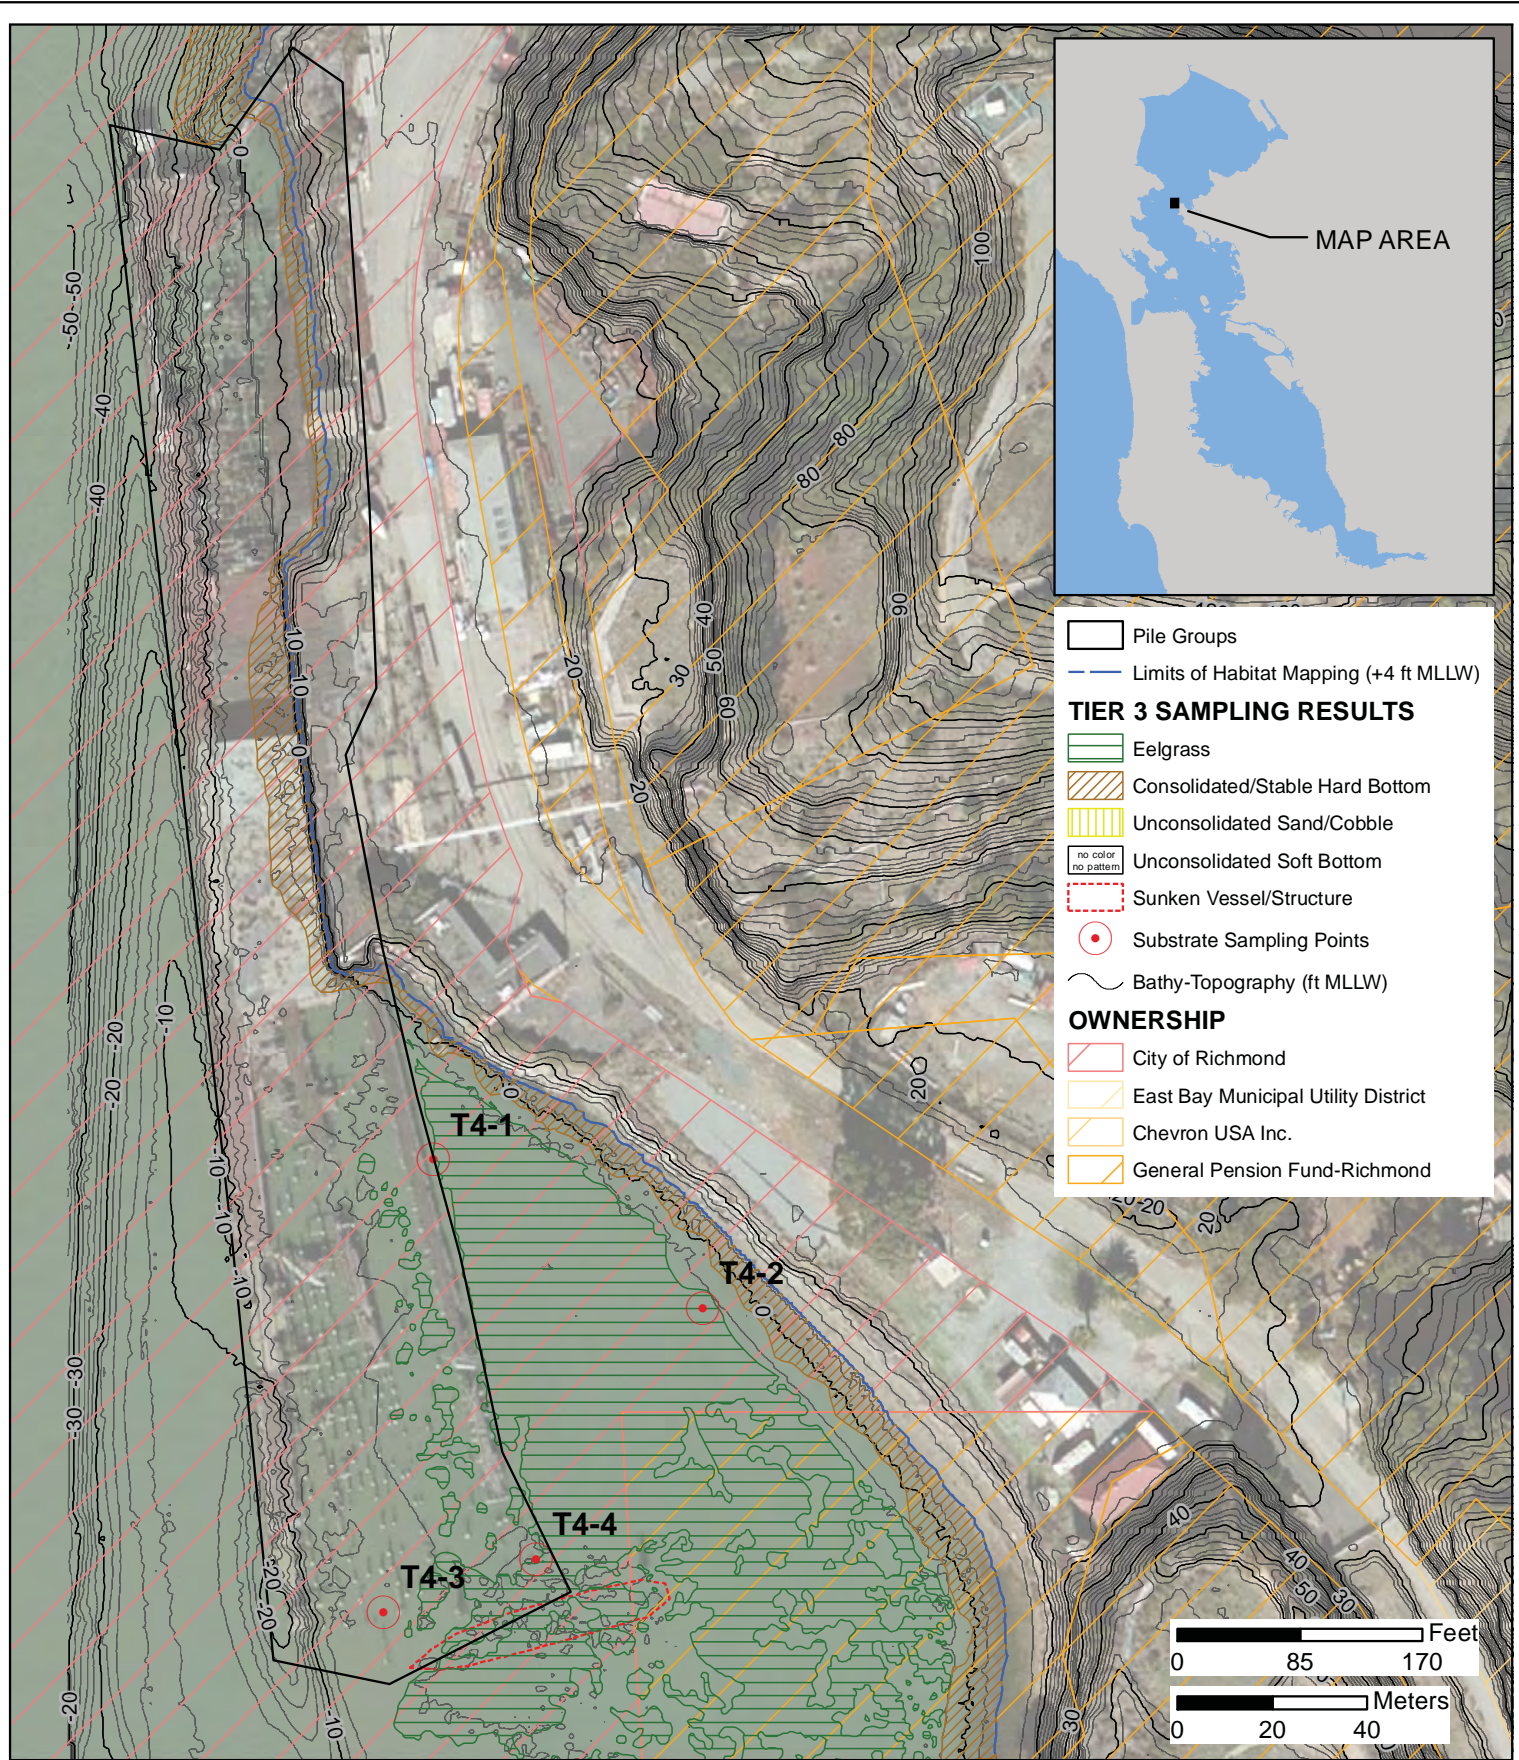
Figure 4

It is not clear when Terminal 4 ceased full operations. By 1987, however, the pier had fallen into a state of significant disrepair and much of the structure and decking at the north end of the terminal had been damaged or lost. Between 1997 and 2002, a substantial portion of the pier north of the overwater warehouse was redecked and considerable investment was made to bolster some of the structural support members beneath the deck. Continued reliance on the failing support beams and piles, however, ultimately has resulted in the new decking buckling and failing with most of this redecking project now being unsafe to walk or drive on. The pier is presently in a condemned and likely unsalvageable state.

Richmond Terminal 4
SAN FRANCISCO BAY CREOSOTE PILING REMOVAL
AND PACIFIC HERRING HABITAT RESTORATION PROJECT

The site sediment characteristics were investigated at four locations identified as T4-1 to T4-4. Sites were distributed within the cove at the south end of Terminal 4 and within accessible areas of the southern end of the pier (Figure 4). The sampling was conducted both near shore and further removed from the rocky shoreline and cobble beach environment.

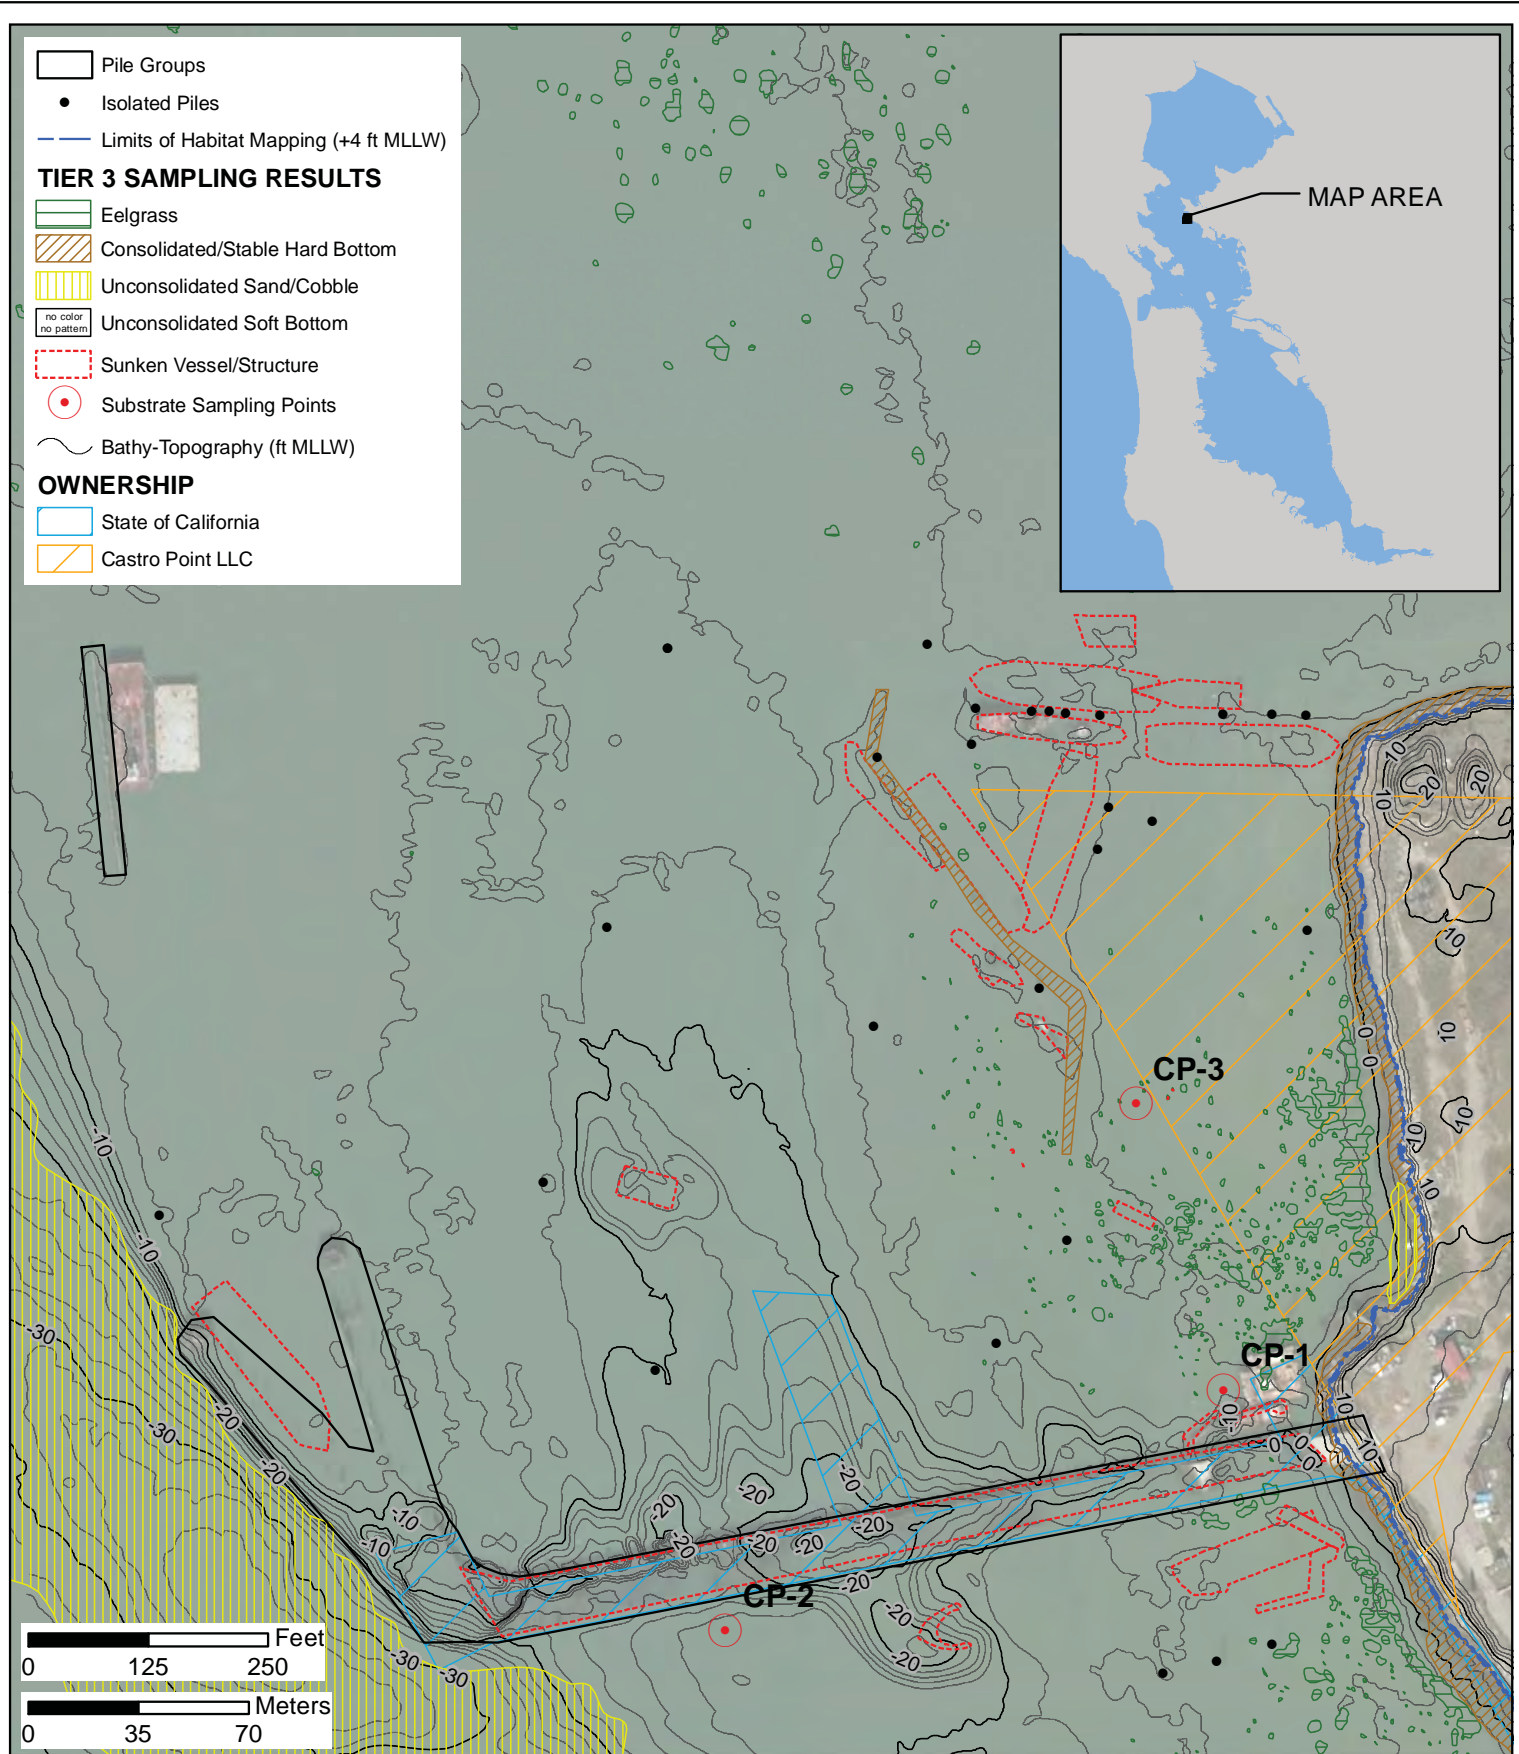
Figure 5

Marina and Ferry Terminal at Castro Point
 SAN FRANCISCO BAY CREOSOTE PILING REMOVAL
 AND PACIFIC HERRING HABITAT RESTORATION PROJECT

The Marina and Ferry Terminal at the Castro Point site extends from the intertidal shoreline out to the edge of a scour hole developed by concentrated flow between Castro Rocks and the Richmond shoreline headlands, including the ferry dock at Castro Point (Figure 5). The general site topology slopes from east to west from -2 feet MLLW to -6 feet MLLW adjacent to the scour hole at a 1:333 (rise:run) gradient. Because of the numerous scour features and submerged material at the site, the overall shallow slope is not readily apparent. From the outer edge of the ferry dock, a steep slope falls away to the bottom of the scour hole at -36 feet MLLW. In addition to this bathymetric low point at the end of the pier, the ferry terminal is designed with a solid piling bulkhead wall along the northern edge of the pier. However, a portion of this wall has been undermined creating a flow path through the bulkhead that has resulted in a smaller scour hole extending linearly through the wall and to a maximum depth of -24 feet MLLW. There are also indications that even smaller breaches through the pile wall are occurring based on scouring immediately adjacent to the wall.

The site sediment characteristics were investigated at three locations identified as CP-1 to CP-3 located adjacent to existing eelgrass on the site where restoration potential may exist and adjacent to the ferry pier where current and wave energy may be substantially modified with the removal of the ferry terminal pier (Figure 5). Additional sediment probing was performed throughout the site.

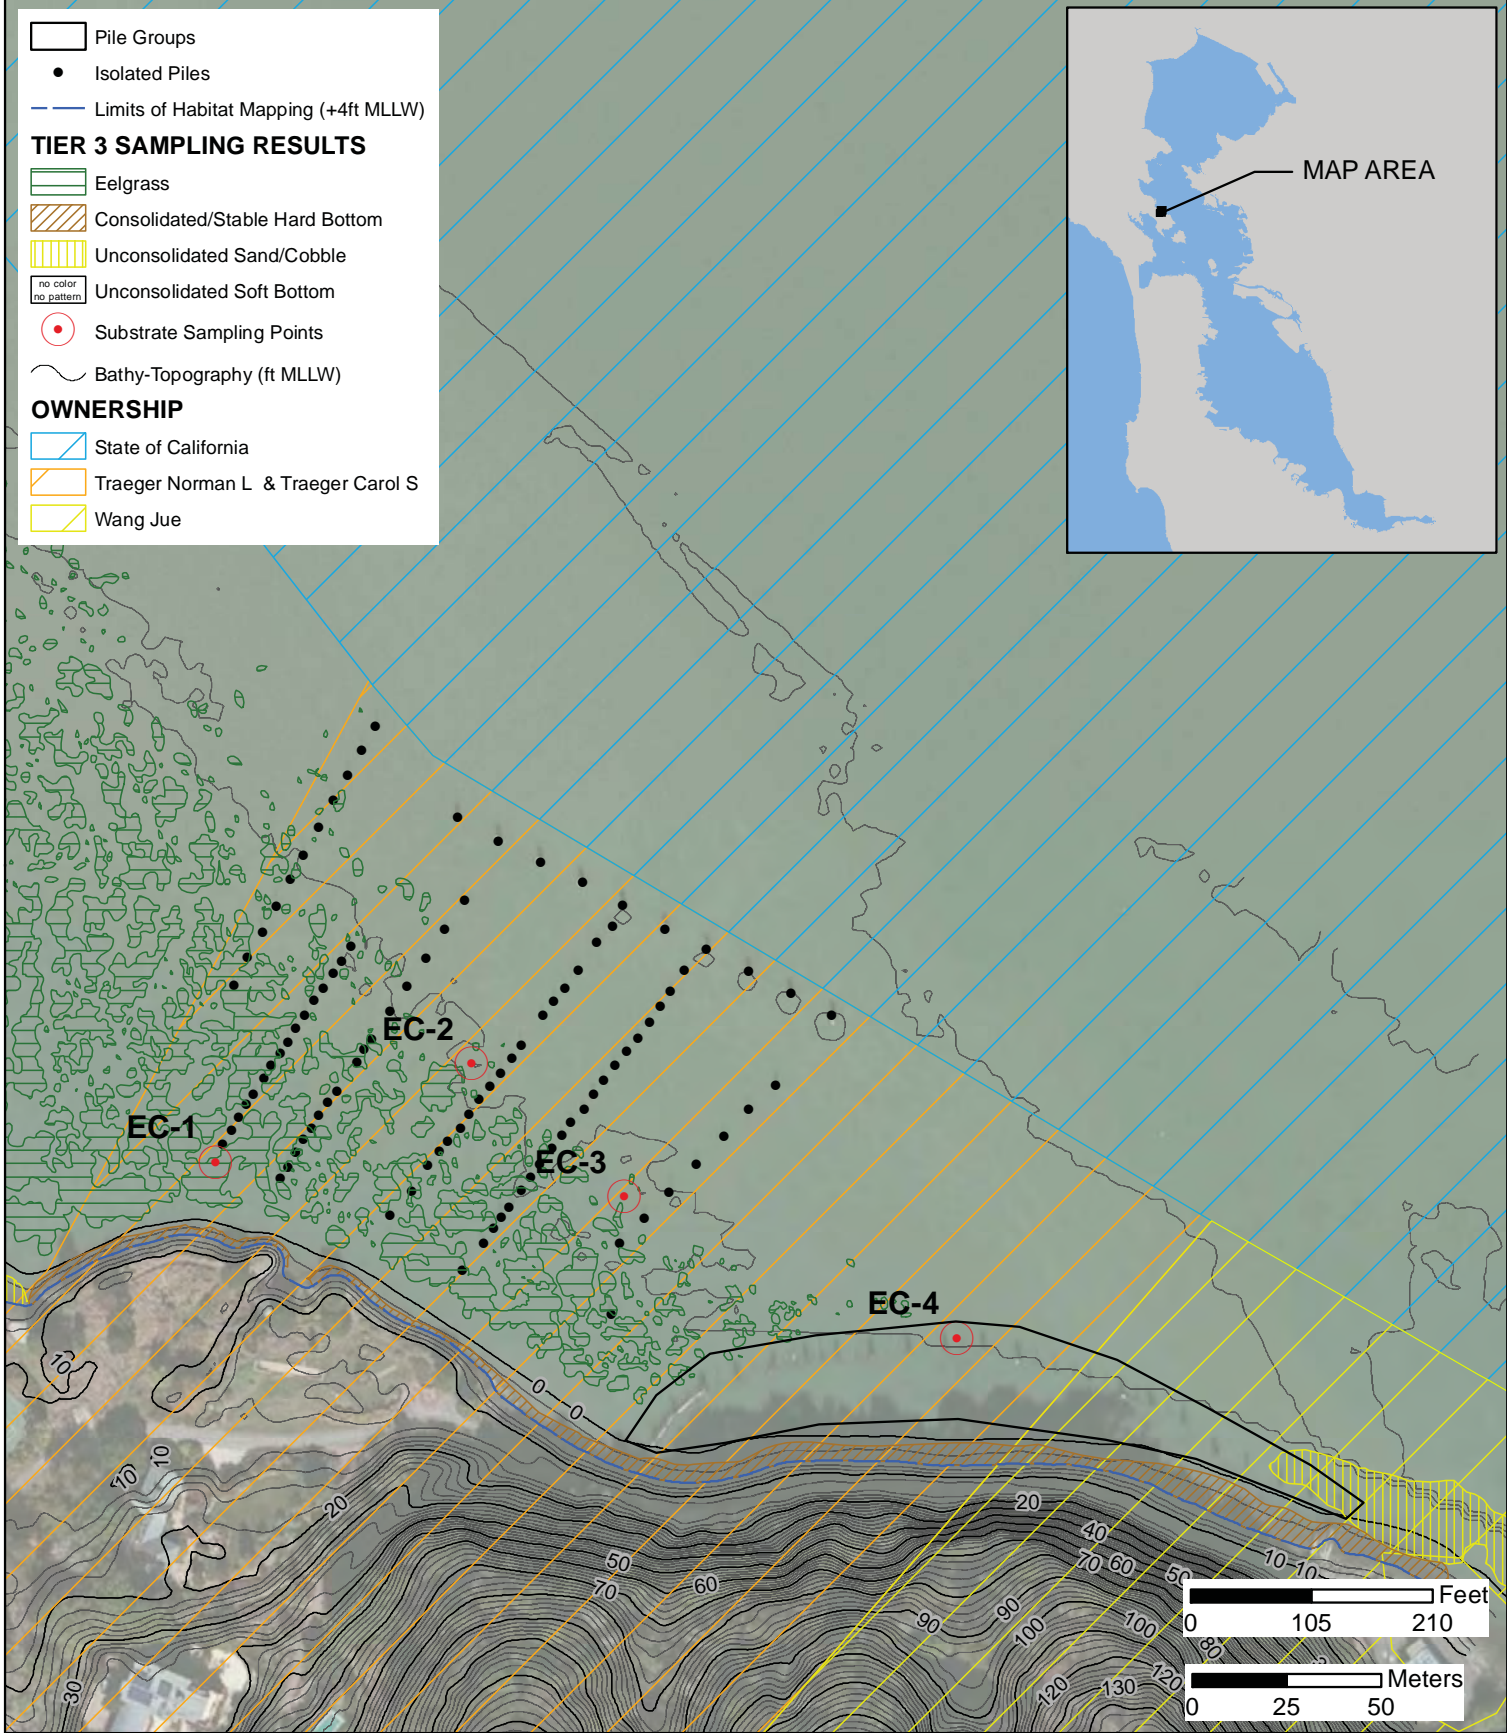
Figure 6

El Campo Site Marina
**SAN FRANCISCO BAY CREOSOTE PILING REMOVAL
 AND PACIFIC HERRING HABITAT RESTORATION PROJECT**

The site sediment were characteristics at four locations identified as EC-1 to EC-4 located within piling field (Figure 6) with additional sediment probing being performed throughout the site at areas close to the shoreline, mid-distance to the channel, and near the channel edge.

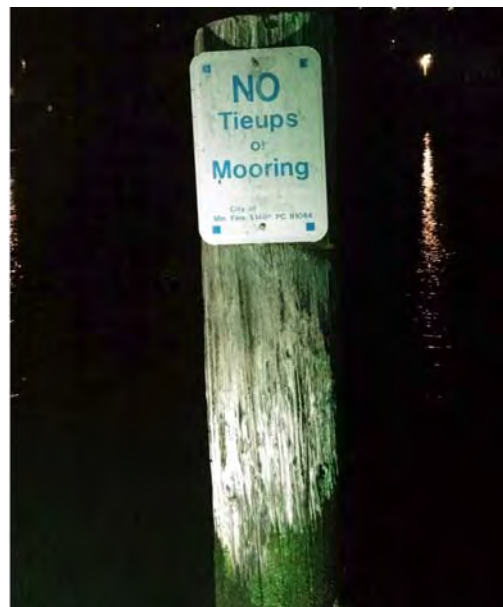
Signage posted on the piles within the cove at the end of Main Street, Sausalito. The signage, although faded reads “Historic Piles and Cove No Tieups or Mooring City of Sausalito Min. Fine \$148.00 PC 81044.”

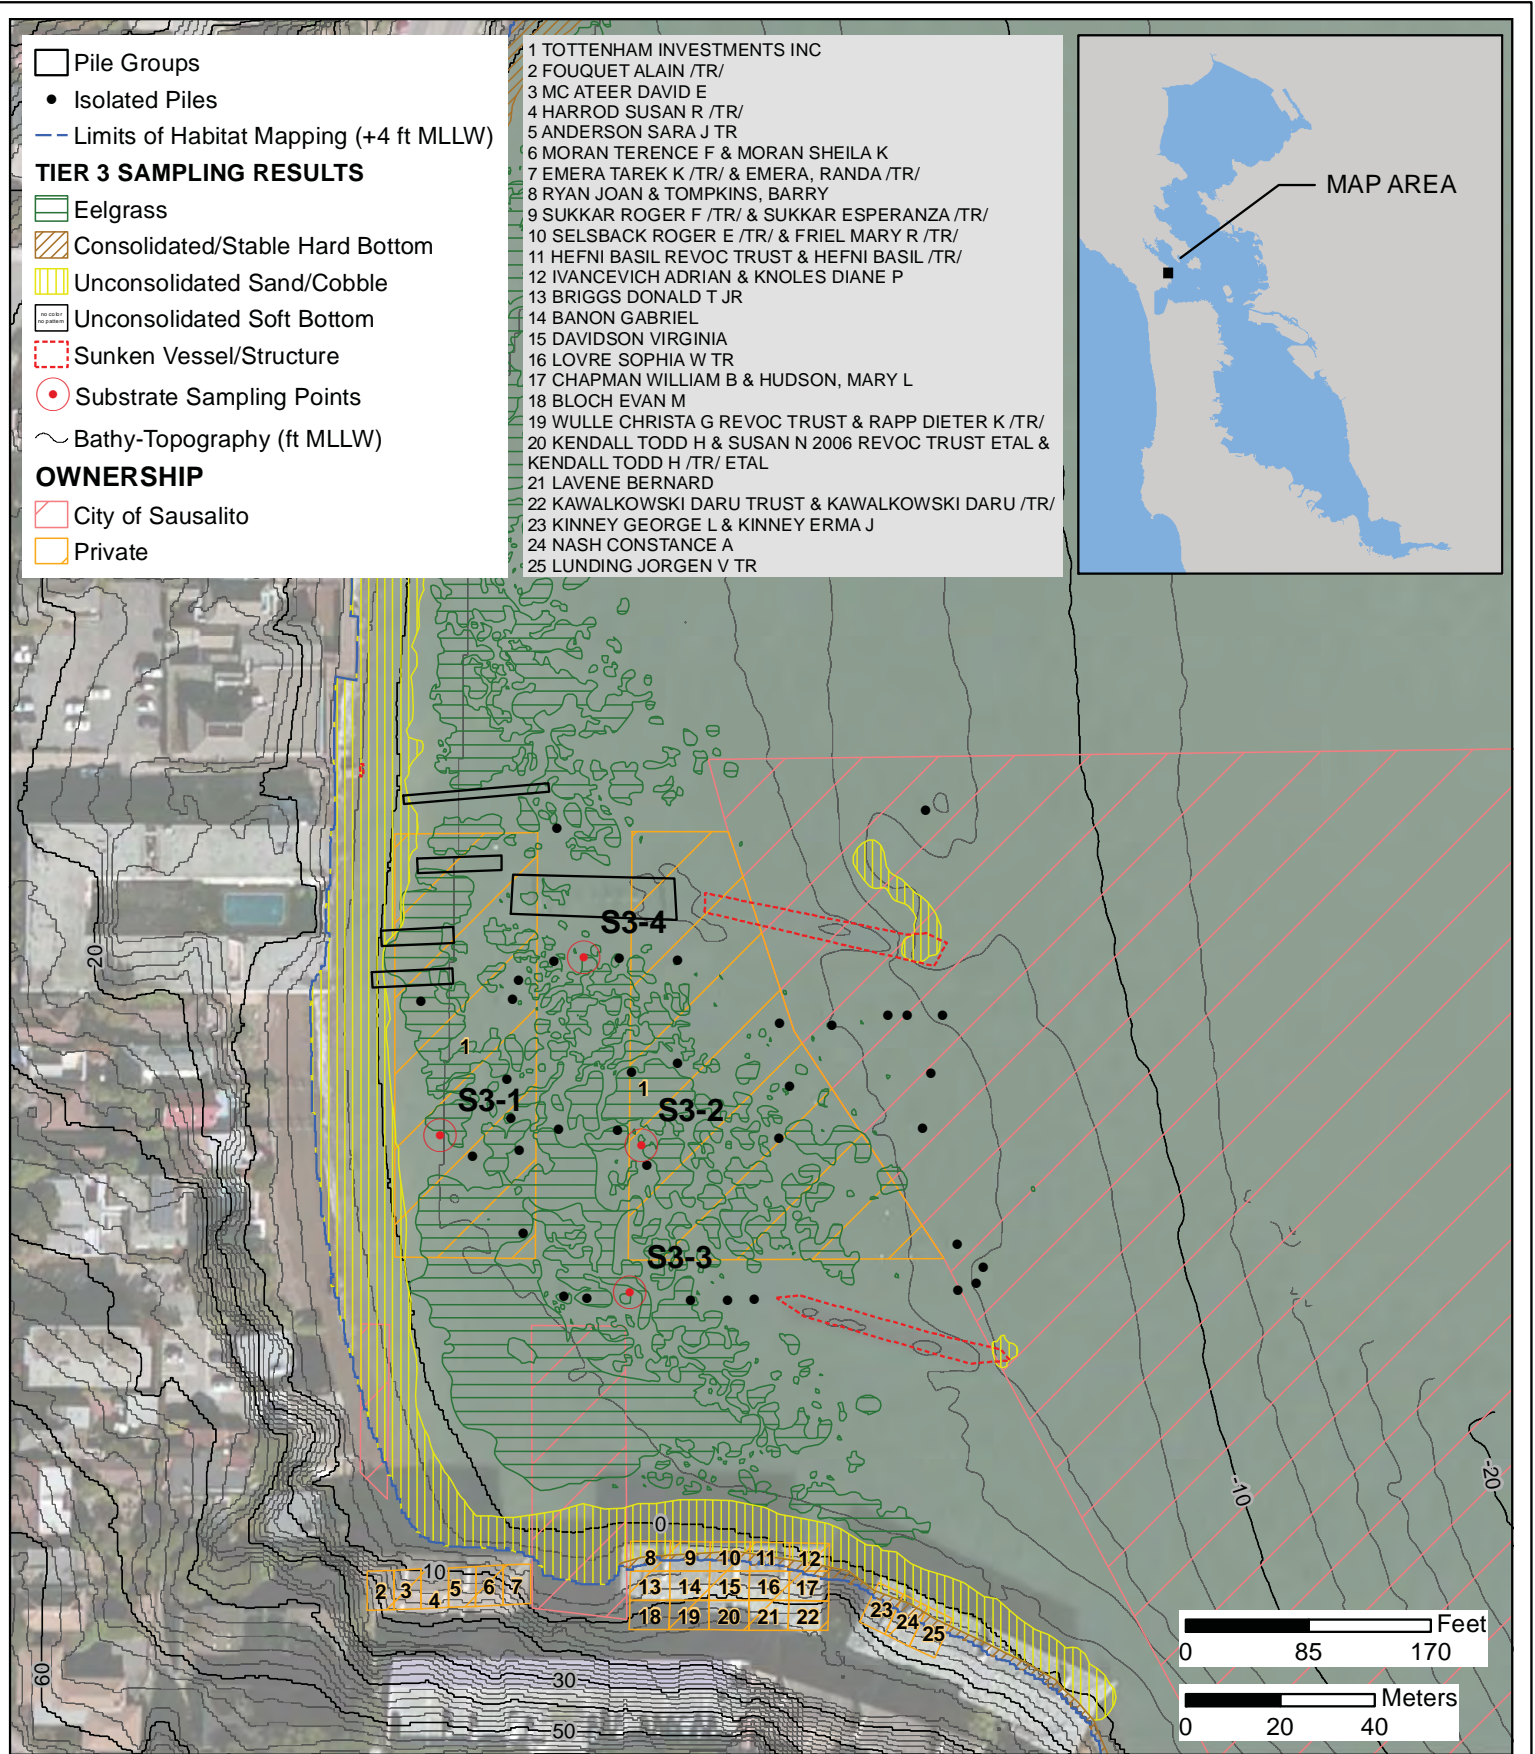
Figure 7

Sausalito 3 (Nunes Bros. Boat & Ways Co. Piers)
SAN FRANCISCO BAY CREOSOTE PILING REMOVAL AND PACIFIC HERRING HABITAT RESTORATION PROJECT

The Sausalito 3 site extends across a gently sloping cove with pile remains extending from approximately 0 feet MLLW down to approximately -6 feet MLLW (Figure 7). The gradient of the bottom is approximately 1:60 sloping downward to the east.
